Winlaw Creek Channel Conditions and Prescriptions Assessment

Prepared by: Apex Geoscience Consultants Ltd.
1220 Government Street
Nelson B.C.,
V1L 3K8

August, 1998

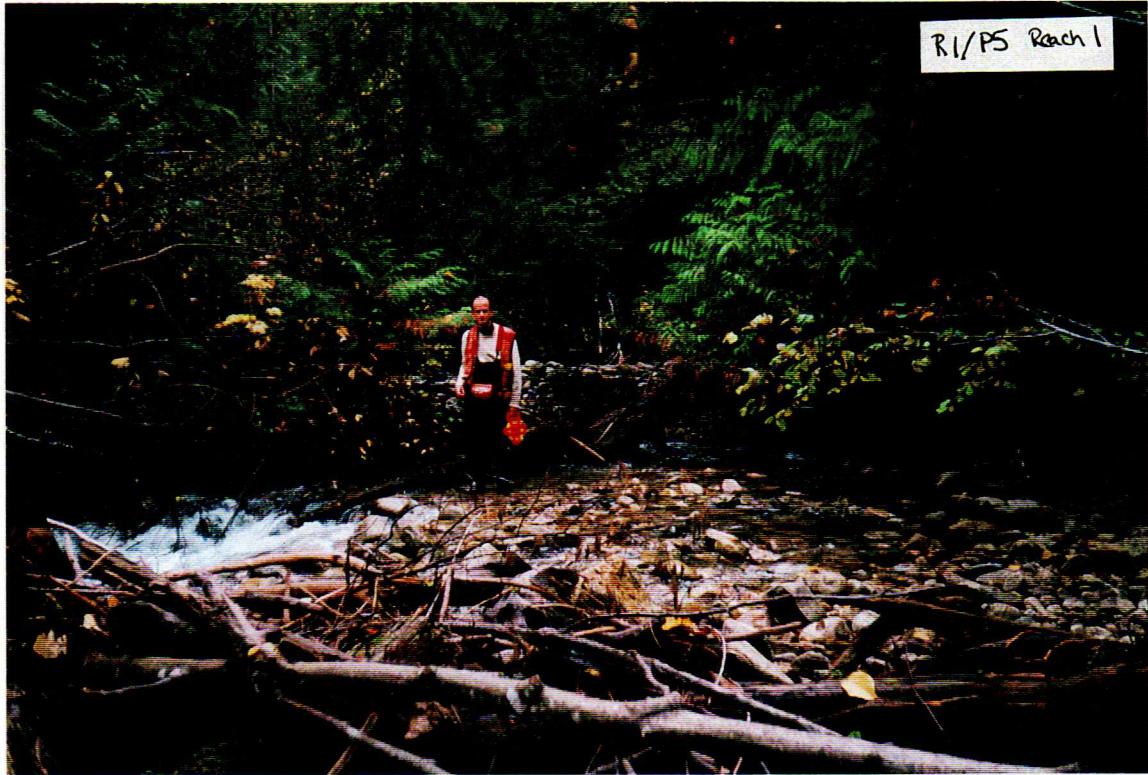
Reach 1 varies from partially degraded to moderately aggraded above the LWD jams. Overall Reach 1 is interpreted as being partially degraded.

Winlaw Creek Reach 1. Cobble/boulder wedge behind LWD jam.

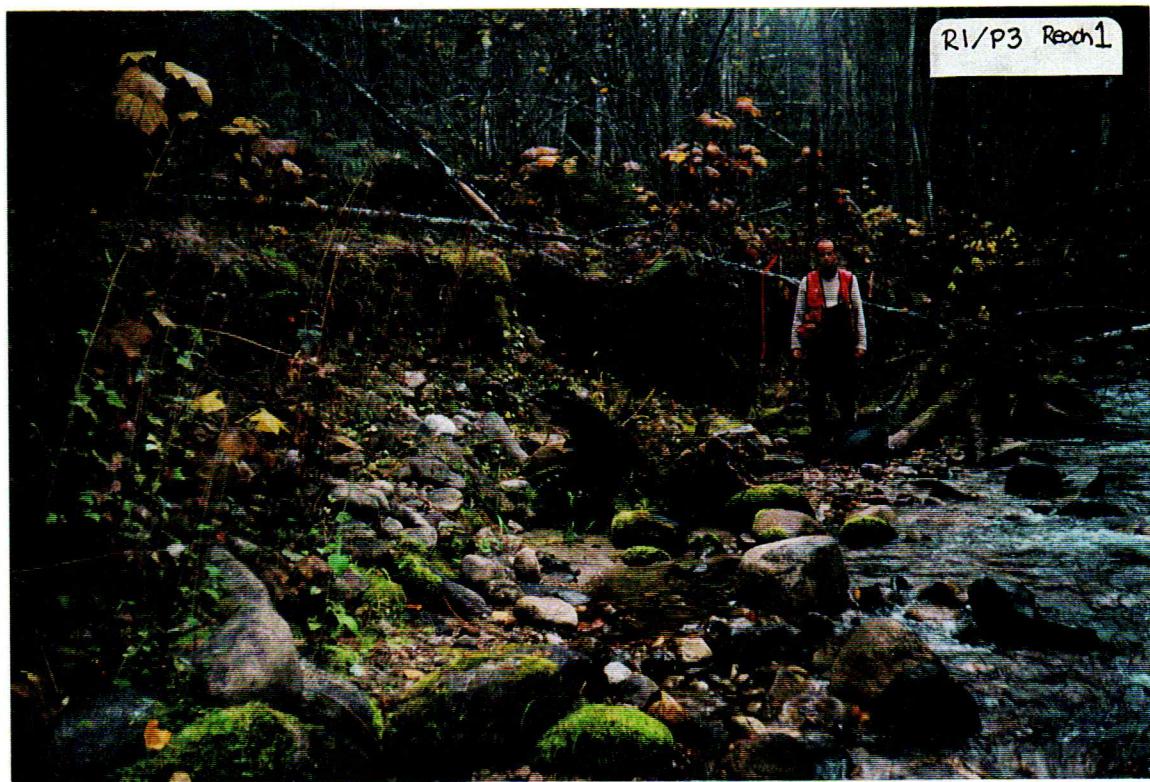
The partially degraded condition of the channel through Reach 1 is likely the result of the last high flow event (1980?) experienced in Winlaw Creek. In a few locations old pieces of LWD were noted on lateral cobble/boulder bars oriented parallel to channel banks. The lack of newly incorporated LWD in the channel is probably, in part, due to development activities adjacent to the channel through this reach.

Winlaw Creek Reach 1. Bank Erosion due to 1980 flood event.

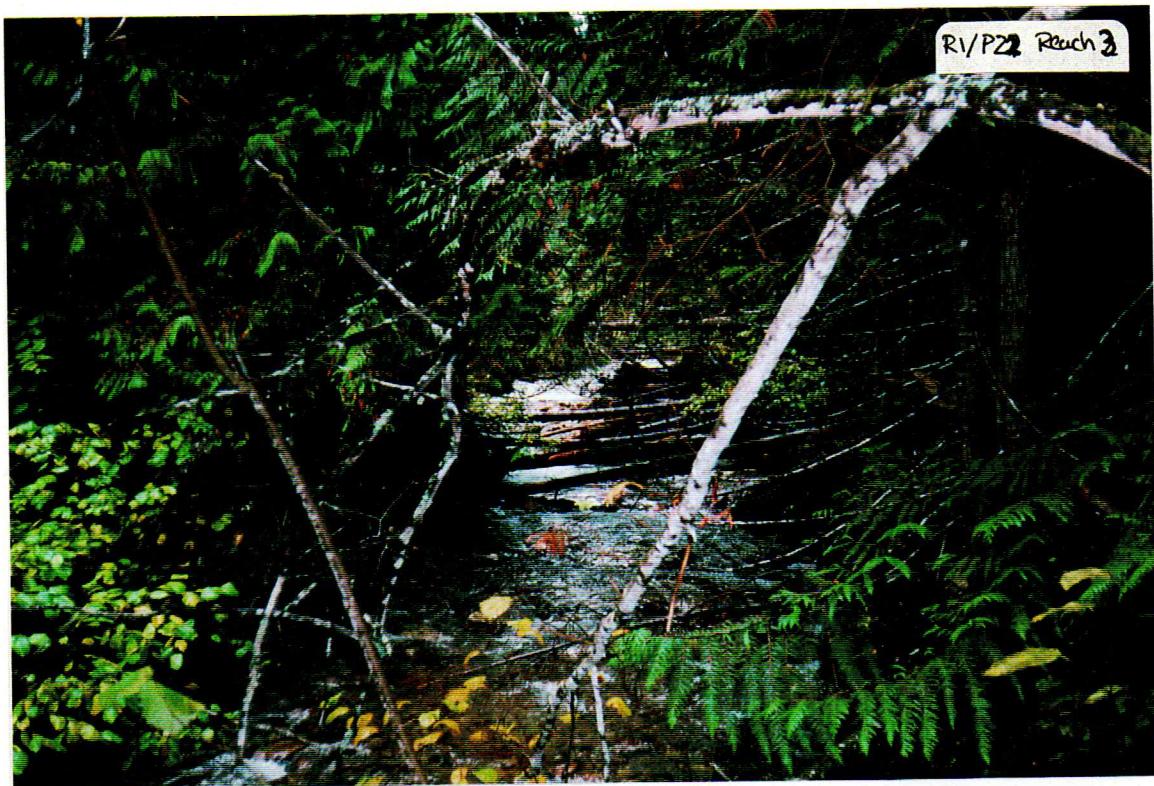
Two segments of channel between 200 to 300 metres long through Reach 3 appear to have been completely unaffected by the 1997 high peak flow event. Both of the unaffected channel segments are confined in places by bedrock along the banks and in the channel. Through these sections banks are overhanging and mossy, boulders and cobbles in the channel are mossy, stone lines are well developed and there are abundant pools and functioning LWD in the channel.

Winlaw Creek Reach 3. Short section of channel unaffected by 1997 flood event. Banks overhanging, LWD in channel.

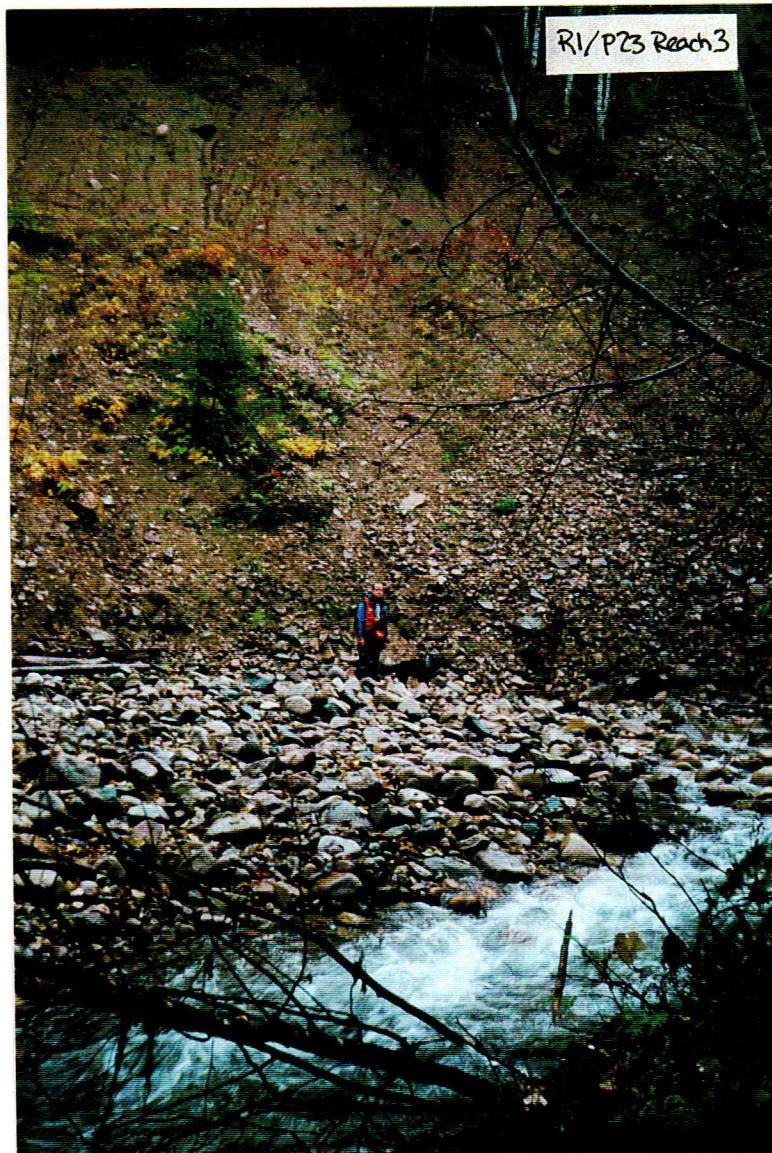
At one location along Reach 3 the Winlaw Creek channel has undercut a section of kame terrace sediments (Photo R1/P23, Appendix B) and the slope is raveling down to the active flood plane of Winlaw Creek. This raveling slope is the only active sediment source noted along the main Winlaw Creek channel. During most years the majority of the sediment derived from this slope is the result of surface erosion during snow melt or heavy rain fall events and it is unlikely that it contributes any significant or detectable amounts of sediment to the creek. Significant amounts of sedimentation from this site would be limited to very high peak flows events (> 1in 25yr flows) when it is being actively undercut and eroded by Winlaw Creek.

Winlaw Creek Reach 3.
Only significant sediment source noted along Winlaw Creek. Most sediment entering the channel here is due to surface erosion. Note: Rilling.
